Cooling tower case study

**Detection of abnormality water
event in a cooling tower.
A huge saving in water bill.**

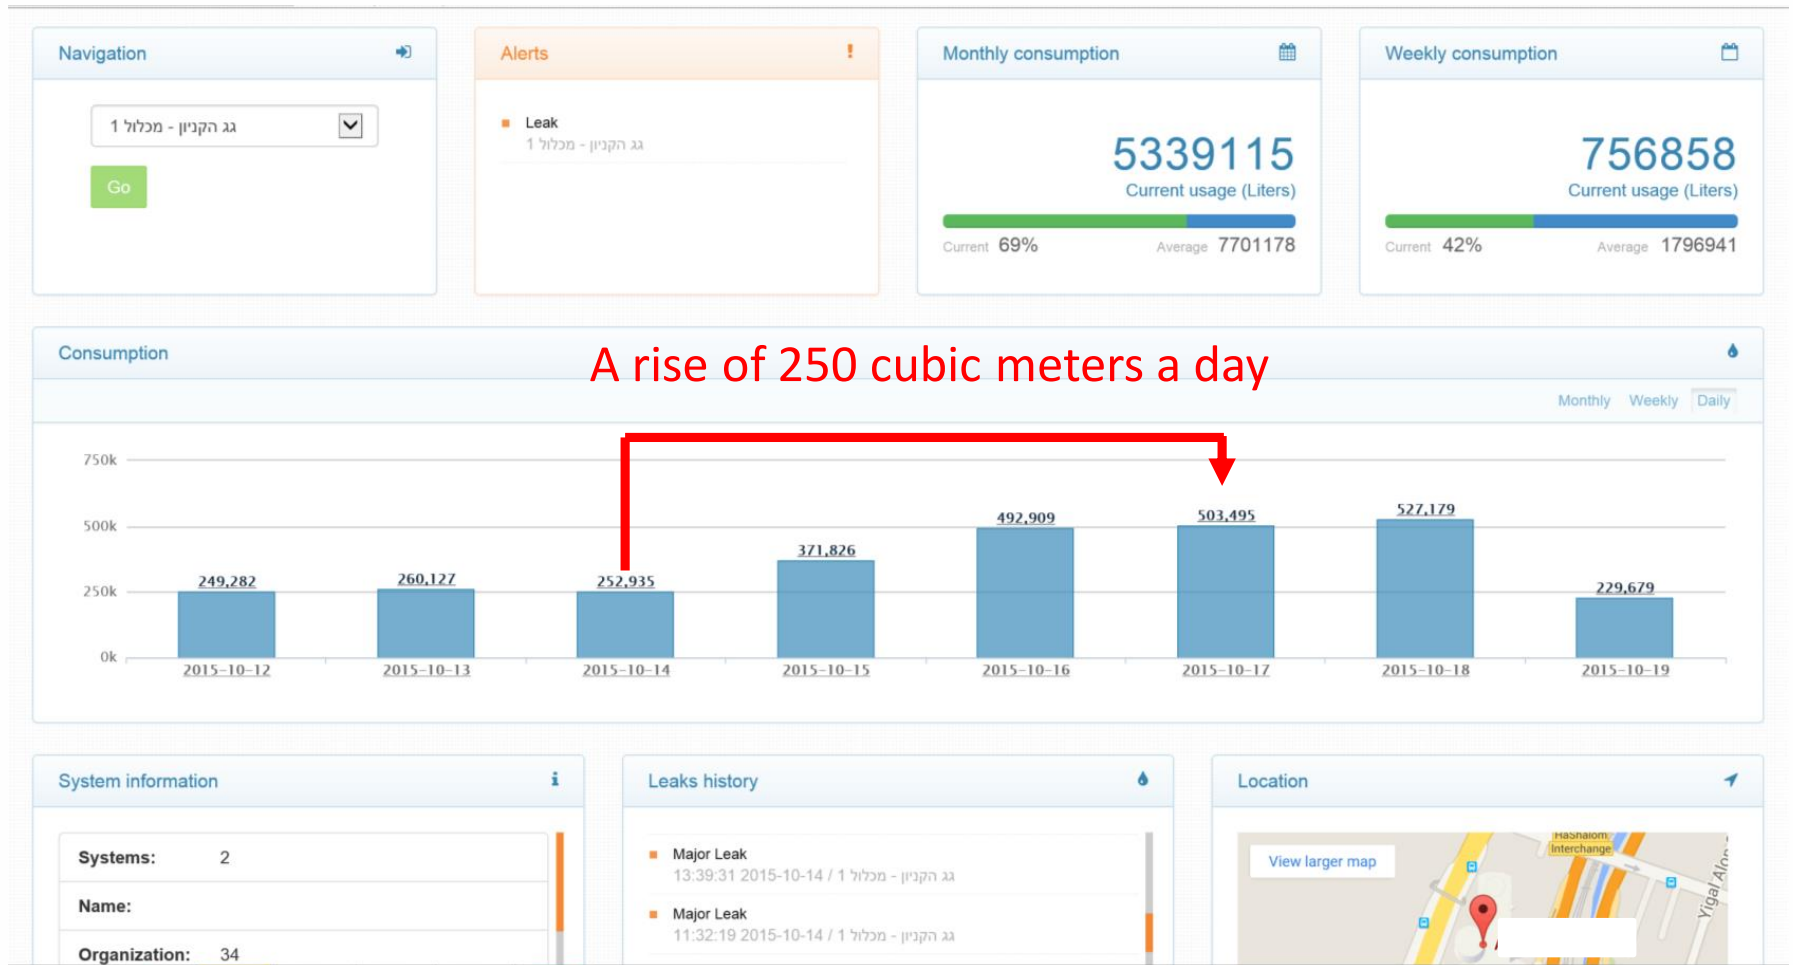
And a significant rise of 250 cubic meters a day, which costs thousands (rise of 66,403 gallons a day)

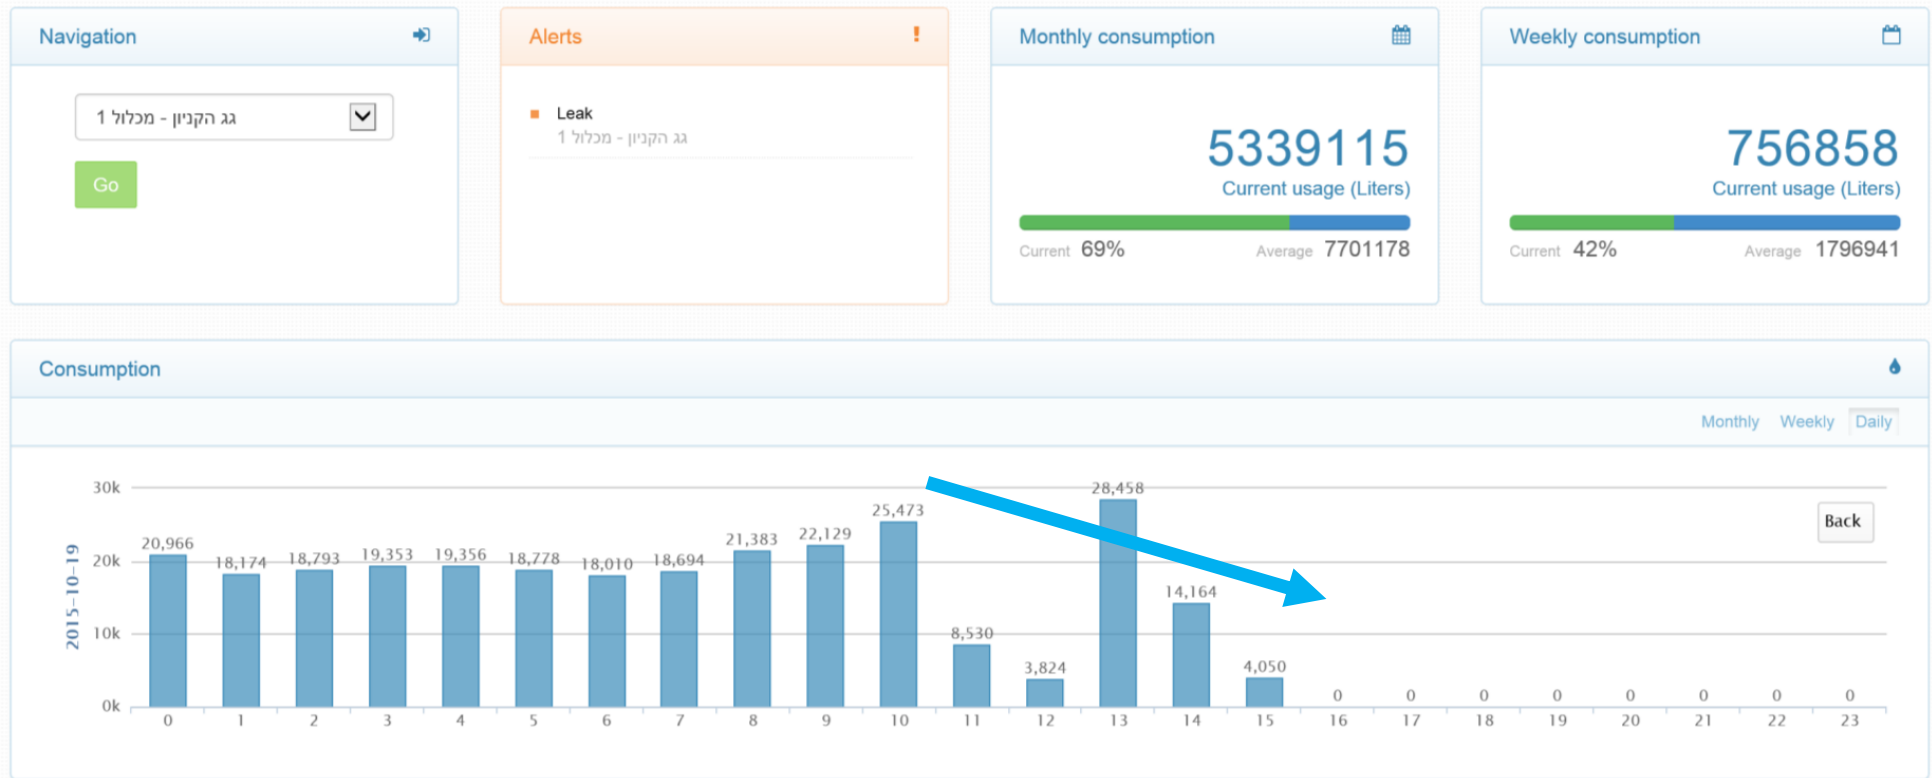
Fault detection, fixing, and back to normal
